# Manhole Inspection Summary

Manhole # S15CC2012MH

Insp Date: **8/3/06 8:11 AM**

**Location** Address: **1910 SULGRAVE AVE**

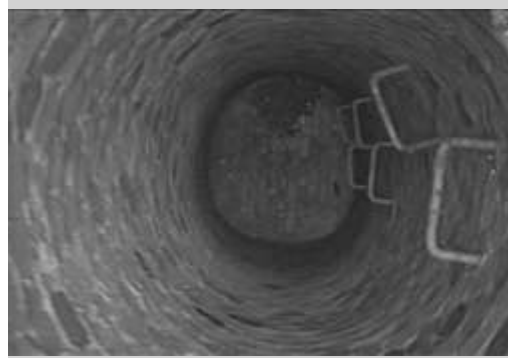
Top View

☒ **Debris** (not Condition related)

Channel debris.

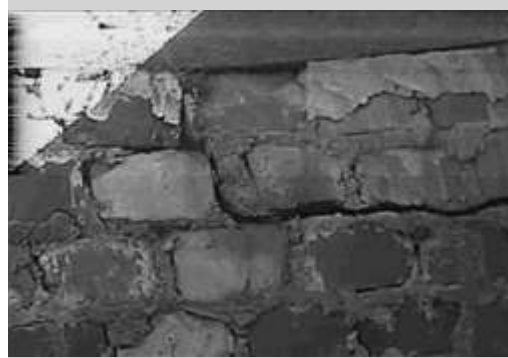
Defect

Condition: ☐ Sound ☒ **Cracked** ☐ Root Intrusion ☐ Loose Brick ☒ **Deteriorated**

Infiltration: ☐ None ☒ **Joint** ☒ **Cracks** ☒ **Mortar** ☐ Roots ☐ Wall

Adjustment deterioration, cracks, and infiltration.

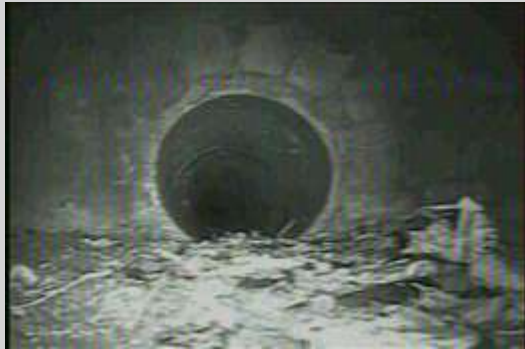
8 in. Circular Gravity Sewer  
Pipe Out @ 12 O'Clock

Channel debris.

Deposits: ☐ None ☐ Mud ☐ Sludge ☒ **Debris** ☐ Grease

Deposits Extent: **Light**

Pipe Seal Cond: **Cracked**
